Engineering for Polar Operations, Logistics, and Research (EPOLAR)

Extreme Cold Testing of High Performance Fabric Materials

Gelbo Flex, Tensile Strength, and UV Exposure Test Results

July 2014

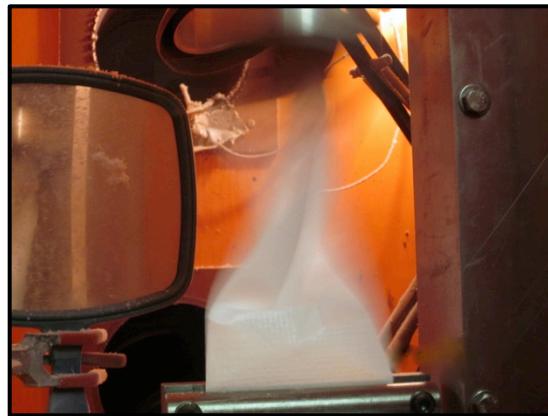
The Gelbo tests revealed significant differences in the two products. The ILPS black shell, white liner, and combined system survived (qualitatively) each test at successively lower temperatures (down to -60°C) with no apparent failures, degradations, or deformities of the shell, liner, or complete system (Figure 1).

Figure 1. ILPS fabric sample during Gelbo flex testing at -40°C . Note that the extreme twisting caused multiple folds but that these did not propagate cracks, tears, or deformities.
